ROOF INSPECTION · SEPTEMBER 23, 2026

Roof Inspection Report

1120 W 800 N

Salt Lake City, UT 84116

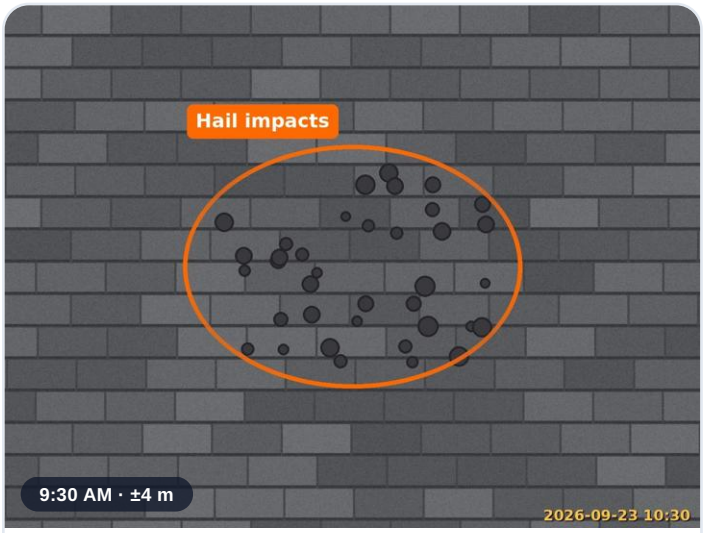
URGENT **Shingles** #1

Dense hail impacts on the west slope, 12+ per test square. Mat is fractured in several spots.

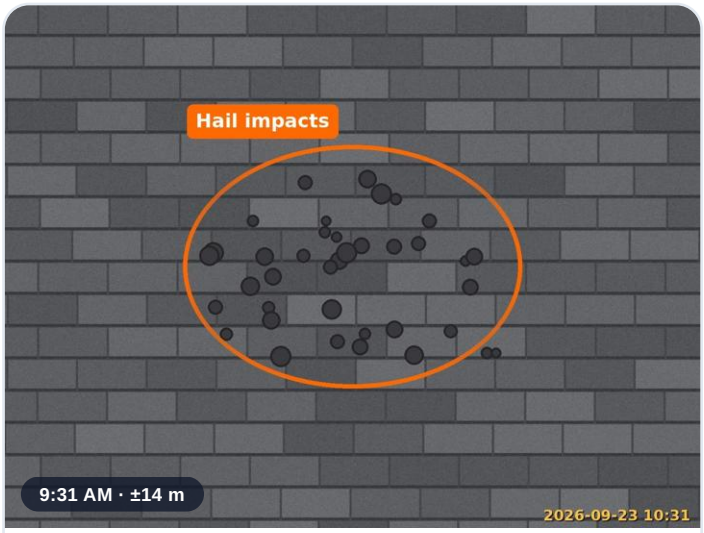
Hail from the September storm bruised shingles across the west and south slopes. With two layers and a 19-year-old 3-tab roof, repairs are not cost-effective. Plan for replacement.

Hail hits in a 10 × 10 ft test square (worst slope)
12

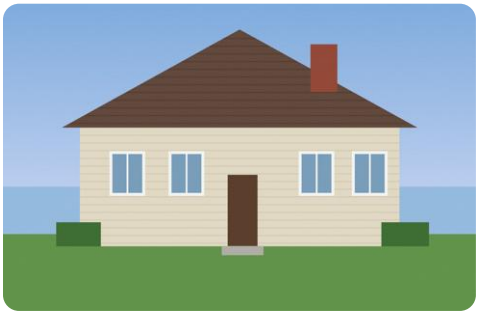
REPAIR SOON **Flashing** #3

Step flashing at the chimney has a gap at the second course. Reseal or replace.

#3 REPAIR SOON **Flashing** · Step flashing at the chimney has a gap at the second course. Reseal or replace.

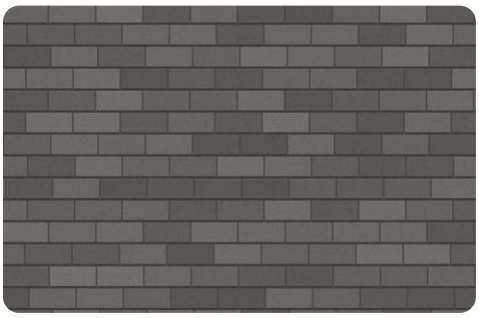
#1 URGENT **Shingles** · Dense hail impacts on the west slope, 12+ per test square. Mat is fractured in several spots.

! No missing, cracked, or creased shingles
See finding #1
